Energy measurements in 2 test rooms

Title:	Energy measurements in 2 test rooms for THERMACOTE HELLAS
Report Nr:	EML 50/2015
Author:	Andreas Androutsopoulos, Mechanical Engineer, MSc Head of Energy Measurements Laboratory

The ability of a high performance Ceramic coating to contribute to the reduction of the energy needs of a building was investigated in this study. Energy measurements took place in two identical Test Rooms placed outdoors, one equipped with coating and the other without coating and their thermal behavior was recorded. The measurements took place in Mandra area, near Athens, Greece during summer conditions. Measuring equipment was placed on the Test Rooms and recorded air, surface temperature, heat losses, energy consumption and ambient conditions and compared the data collected. Results showed that the Test Room equipped with the coating outperforms the other Test Room presenting lower temperature distribution in every measured surface, vertical or horizontal, exterior or interior. The thermal resistance of the walls was calculated according to ISO 9869" and it was found that the wall equipped with the coating provides with a thermal performance 31% higher than t

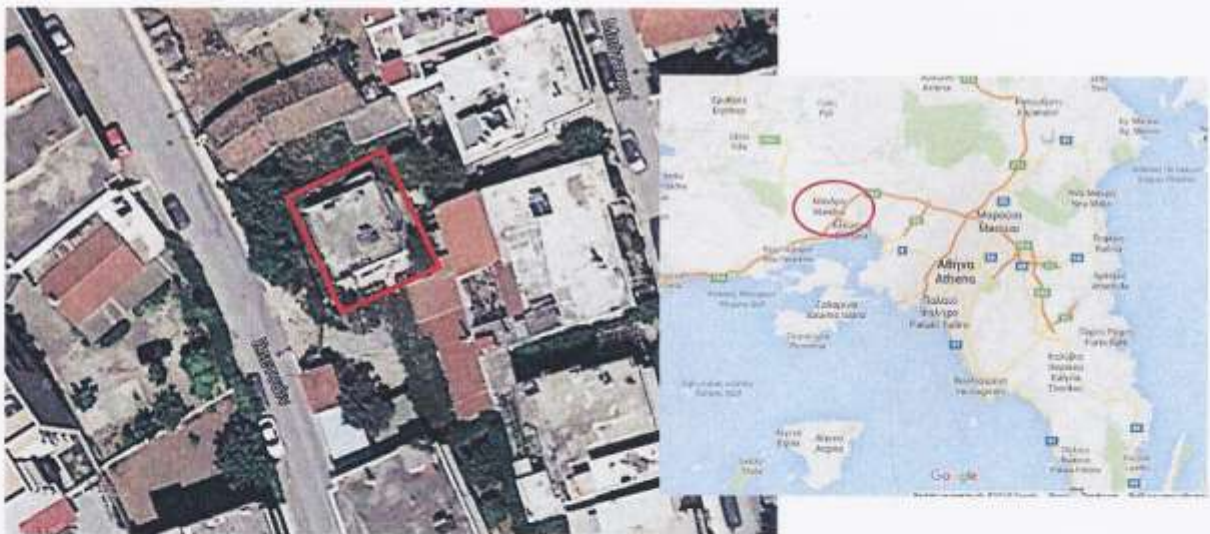
Figure 1: Mandra area – building used to place the test rooms. [source: Google Earth]

For the purpose of the study, two identical test rooms were constructed so as to measure the temperature distribution and heat losses and compare them. The two test rooms were constructed on the roof a single-storey house in Mandra area, in Attika prefecture (refer to Figure 1). The total dimensions of the rooms are: 2.0 m length x 2.0 m width x 2.15 m height. The test rooms were positioned in such an area so as the walls have no shading offered during daytime (see Figure 2). The outer surface of the first Test Room (hereafter called Test Room 1) was coated with ThermaCote coating (0.7 mm thickness). Additionally, its internal surface was also coated with ThermaCote coating at 0.3 mm thickness resulting in a total wall thickness of 95.5 mm. The second Test Room (hereafter called Test Room 2) is identical to Test Room 1 except for the ThermaCote layers.

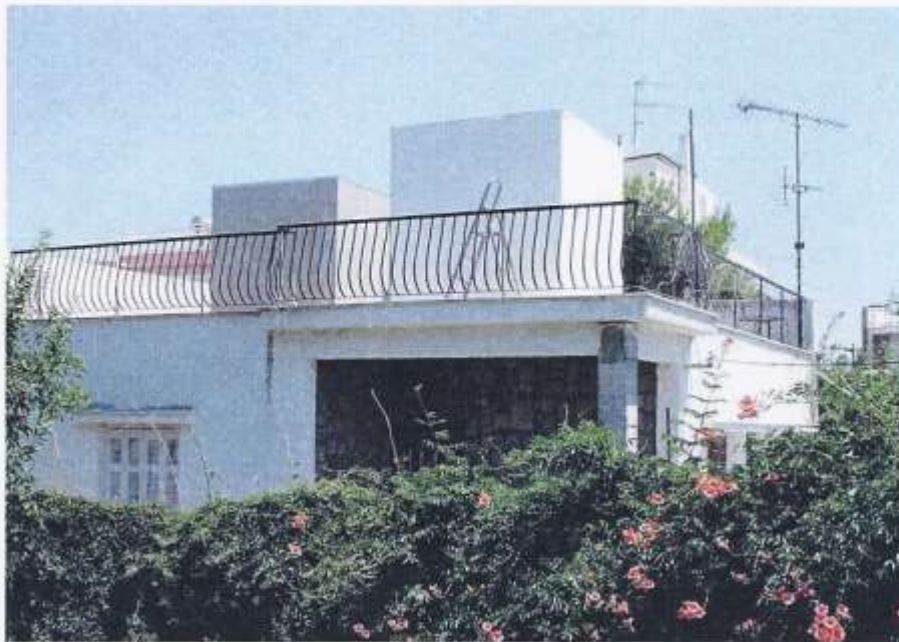
Figure 2. The two test rooms positioned on the roof – View from the West.

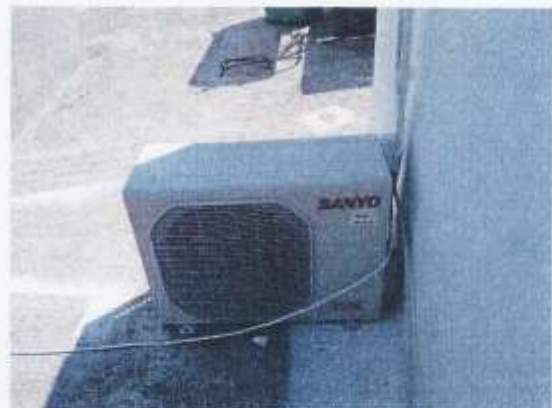
Figure 4. Test Room AC unit.

Additionally, the Test Rooms are equipped with an air conditioning unit to control the indoor environment. The AC is a slit type unit, of 9.000 Btu/h cooling capacity (refer to Figure 4)

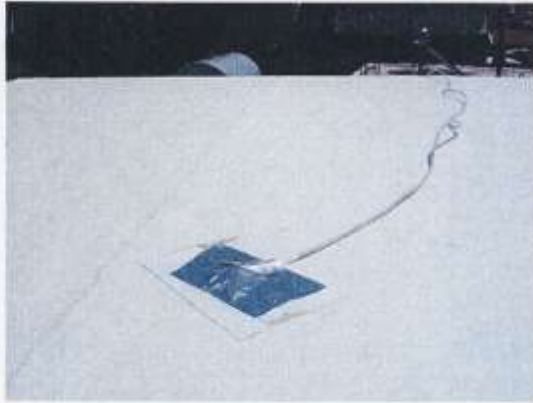
Figure 7. Roof temperature sensor.

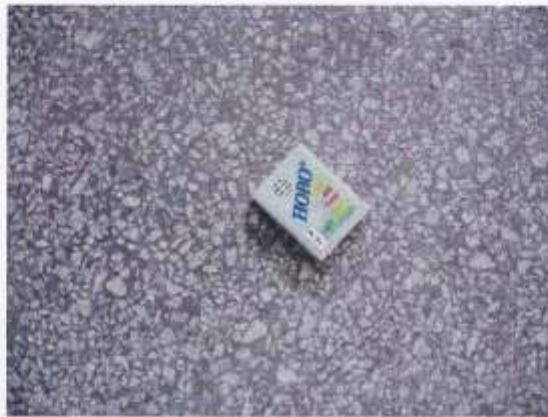
Figure 9. Room air temperature sensor.

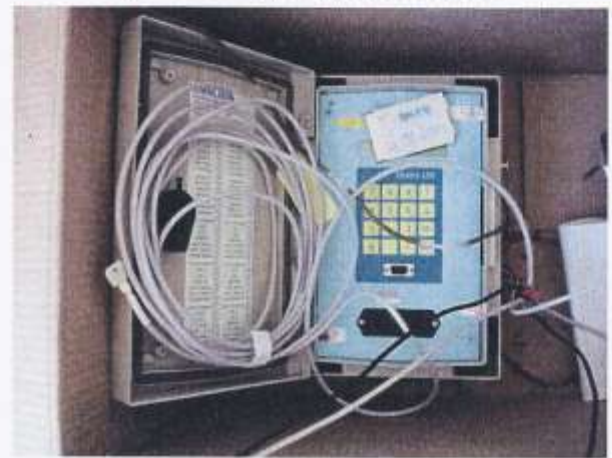
Figure 10. Data logger.

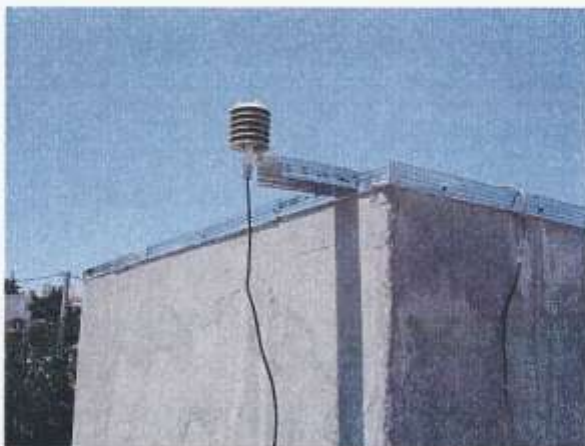
Figure 11. Ambient temperature sensor.

Apart from the above mentioned sensors, the ambient temperature and the solar radiation on a horizontal plane were also collected. These sensors were placed at the top of Test Room 2 roof (refer to figures 11 and 12). Attention was paid so that the sensors remain no shaded during daytime.

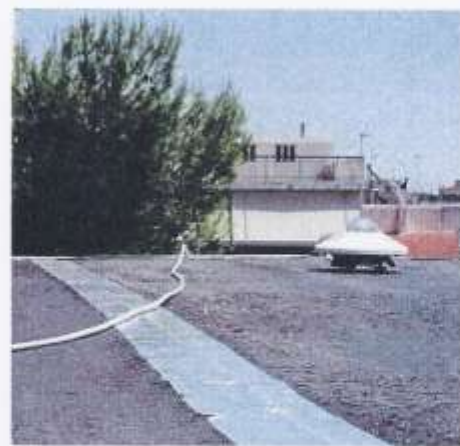
Figure 12. Solar radiation sensor on top of Test room 2 roof.

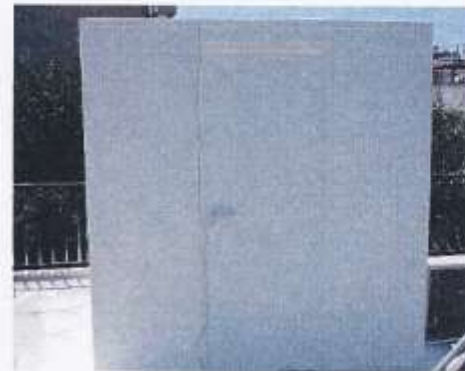
Thermograph 1 shows the variation in exterior temperature on Test Room 1 with East orientation. It can be seen that the various surface temperature ranges from 34.7 to 36.9 °C. It is noted the temperature homogeneity of the surface although it is comprised of different building materials, i.e. plaster, metallic areas, which is attributed to the complete spread of the coating.

Figure 13. Test Room 1 - East wall.

Measurement Point	Temperature (°C)
SP01	35.6°C
SP02	35.3°C
SP03	35.2°C
SP04	35.8°C
SP05	35.7°C
SP06	36.6°C
SP07	36.6°C
SP08	36.3°C
SP09	36.5°C
AR01: max	36.9°C
AR01: min	34.7°C

Thermograph 1. Test Room1 - East wall.

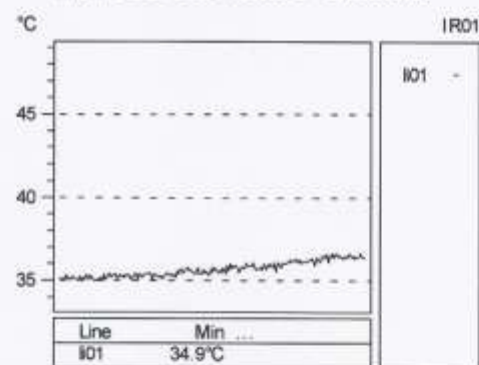
Diagram 1. Surface temperature over line LI01.

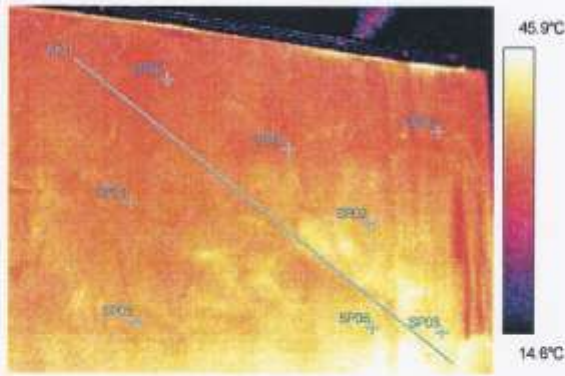
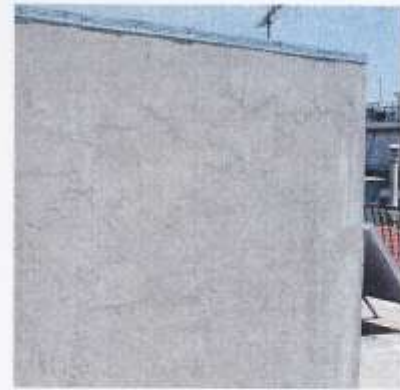
Thermograph 2 shows the variation in exterior temperature on Test Room 2 with South orientation. In this wall the various surface temperatures range from 43.5 to 45.7 °C. A temperature difference between the two walls of appr. 9 °C is notable. It should be noted that all wall surfaces of the Test Rooms showed similar temperature readings.

Measurement Point	Temperature (°C)
SP01	44.2°C
SP02	44.6°C
SP03	44.5°C
SP04	43.5°C
SP05	43.5°C
SP06	46.2°C
SP07	44.2°C
SP08	45.5°C

Thermograph 2. Test Room 2 - South wall.

Figure 14. Test Room 2 - South wall.

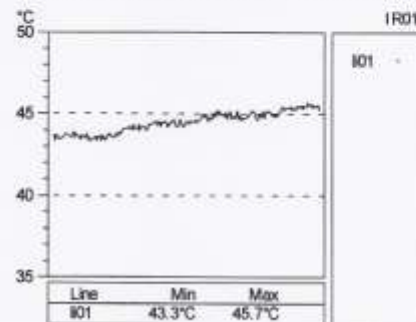
Diagram 2. Surface temperature over line LI01.

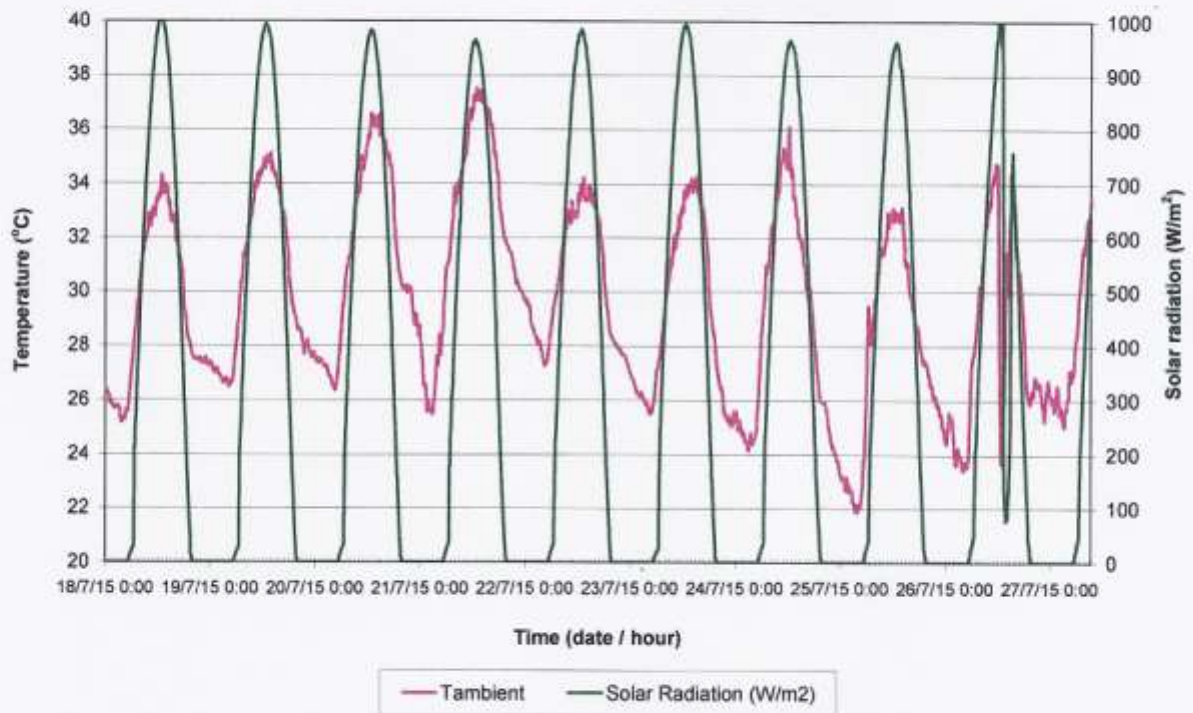
The meteorological data during the testing period in terms of solar irradiation and ambient temperature can be seen in Figure 15. The graphs show the measurements from 00:00' of July 18th until 09:00' of July 27th 2015. It can be seen that the test took place under sunny sky conditions and a rather typical ambient temperature for the Attiki area ranging from 22 to 37.5 °C.

Figure 15. Ambient temperature and solar radiation during the testing period.

The thermal behavior of the Test Rooms was looked into in more detail through the comparison of the measurements of a typical day regime. July 22 was selected for this comparison since it showed a rather typical ambient temperature (up to 34.2 °C) and solar radiation distribution ($G_{sol}=980 \text{ W/m}^2$) with clear sky conditions (refer to Figure 15).

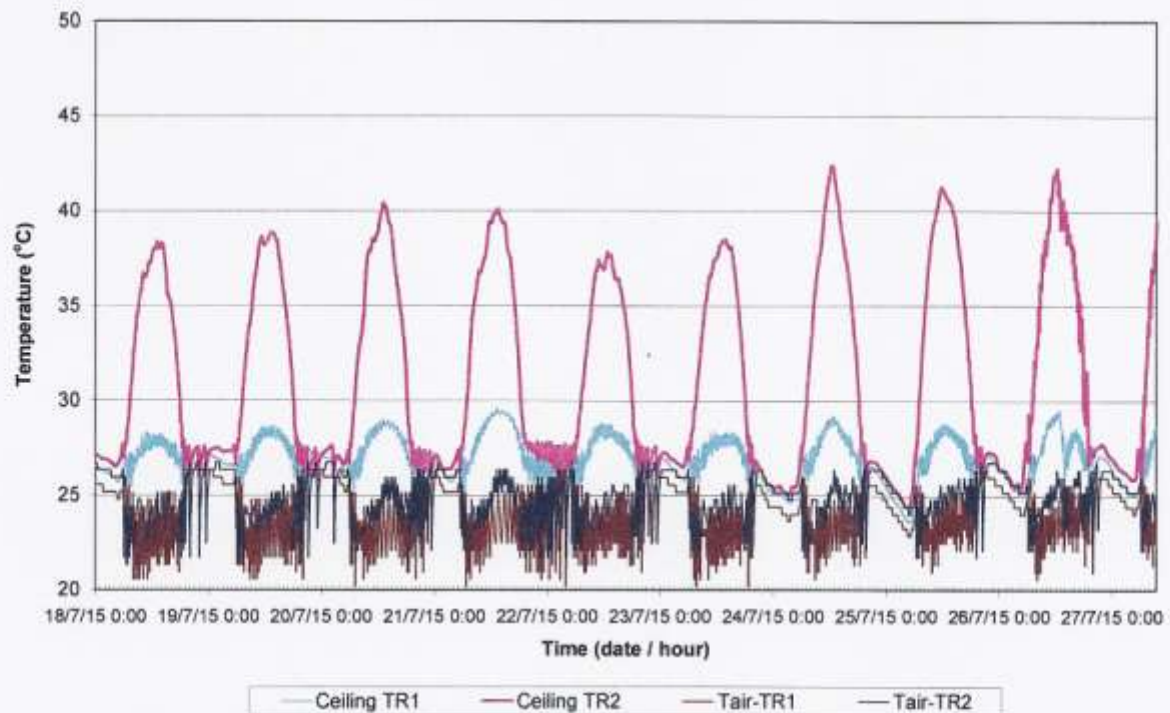
The temperature distribution of the Test Rooms ceiling are shown in Figure 21. During appr. 13:00' the ceiling of Test Room 2 reaches high values (up to 42.4 °C) while the corresponding measurements of Test Room 1 rarely exceed 29 °C. The difference in ceiling temperature is found in Figure 20. The maximum temperature difference ranges between 10.1 and 14 °C. During nighttime, these temperatures are equalized, the ceiling temperature of Test Room 1 being slightly cooler.

Figure 21. Test Rooms ceiling temperature distribution.

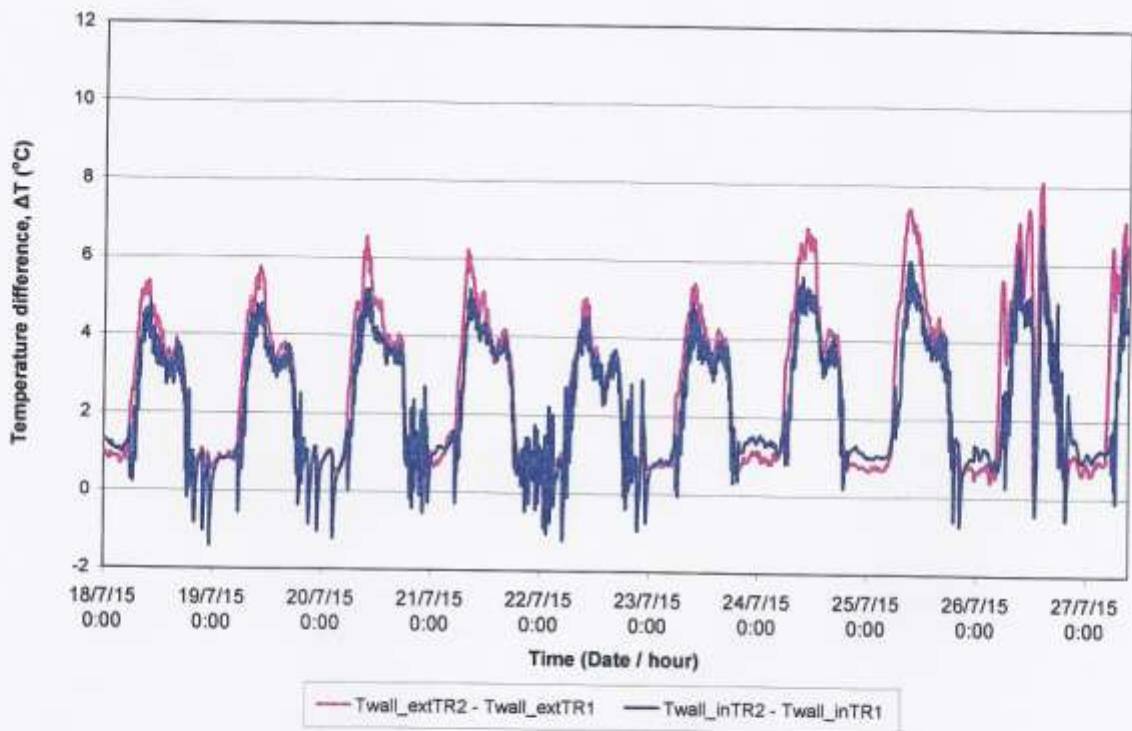
Figure 23. Test Rooms exterior and interior surface Wall temperature difference.

Figure 22 presents the exterior wall temperature distribution of the Test Rooms while their difference is visible in Figure 23. During appr. noon Test Room's 2 wall temperature reaches temperature values up to 45.3 °C while the corresponding measurements of Test Room 1 rarely exceed 38.5 °C. During nighttime, these temperatures are equalized. The maximum temperature difference ranges between 5 and 8 °C (Figure 23). Again, Test Room 1 presents lower distribution of wall temperature than the corresponding wall temperature of Test Room 2, which results in lower surface absorbance and lower energy needs for cooling.

Figure 24 presents the interior wall temperature distribution of the Test Rooms. The interior wall temperature difference can be seen in Figure 23. During appr. 13:00' Test Room's 2 wall internal surface temperature reaches up to 35.2 °C while the corresponding measurements of Test Room 1 reaches up to 30.9 °C. During nighttime, these temperatures are equalized. The maximum temperature difference ranges between 4.3 and 7 °C (Figure 23).

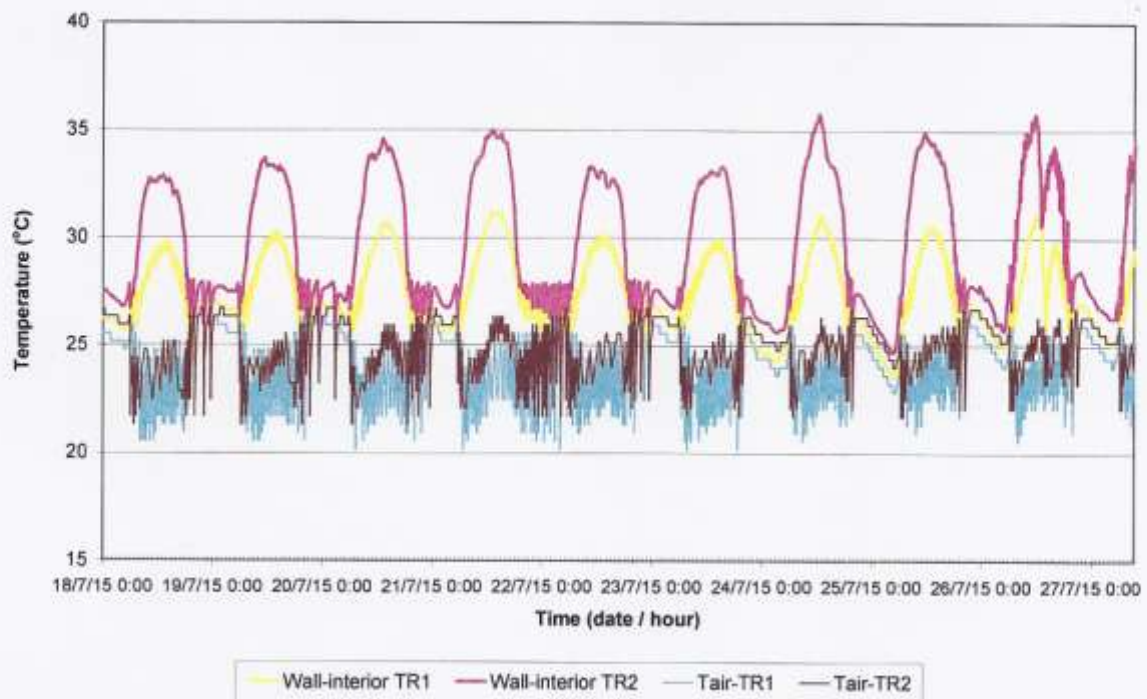
Figure 24. Test Rooms interior wall surface temperature distribution.

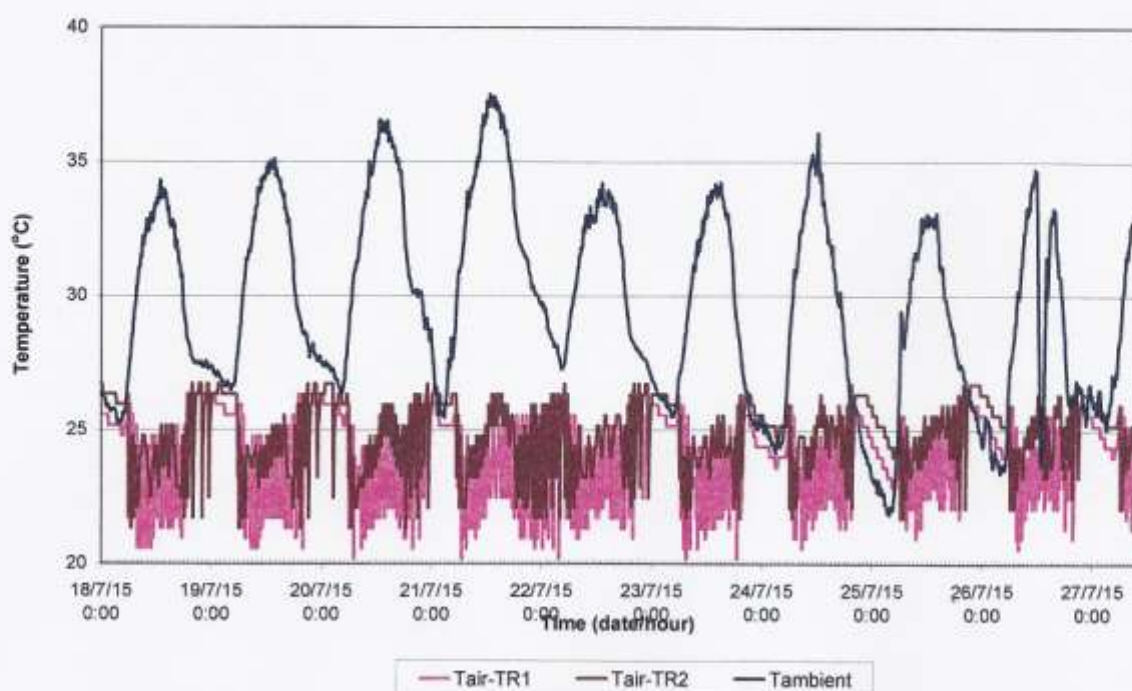
The indoor air temperature distribution of the 2 Test Rooms is presented in Figure 25 together with the ambient temperature. It can be seen that the temperature varies in narrow limits, i.e. from 20.7 to 25.5 °C in Test Room 1, and from 21.7 to 26.7 °C in Test Room 2 depicting the effort to keep the internal air temperature to the set point temperature of the AC unit (26 °C). It can be also seen that the air temperature of Test Room 1 rarely exceeds 25 °C, while that of Test Room 2 more often showing the difficulty of Test Room 2 to keep temperature set.

Figure 25. Test Rooms indoor air temperature distribution.

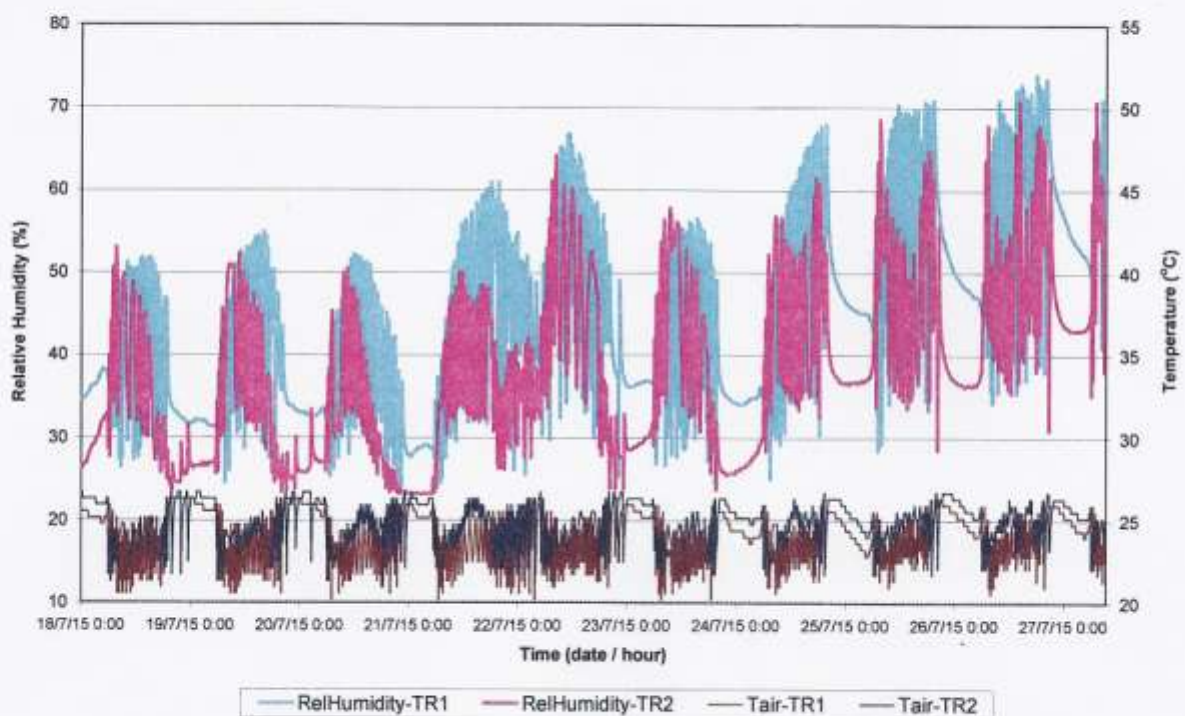
Figure 27 presents the fluctuation of the relative humidity inside the Test Rooms together with indoor air temperature. It can be seen that humidity ranges from 25% to 74% and it lays in acceptable indoor levels.

Figure 27. Indoor relative humidity distribution.

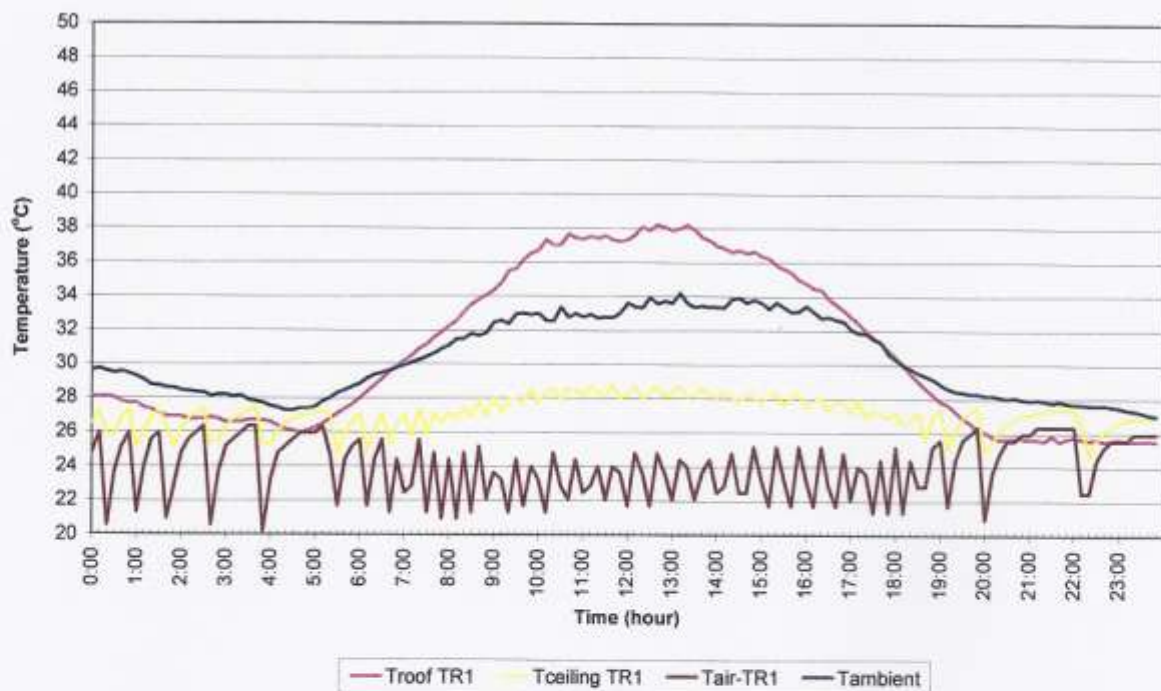
Figure 28 illustrates the roof and ceiling temperature distribution of Test Room 1 together with the indoor air and ambient temperature. Figure 29 shows the same measurements for Test Room 2. It is noted that although the indoor air conditions are similar (approx. 26 °C) a roof temperature difference of 10.4 °C is reached at noon, together with a ceiling temperature difference of 9.5 °C (Figure 30). The average roof temperature difference was found to be 4 °C.

Figure 28. Roof, ceiling temperature distribution - Test Room1 (July 22nd).

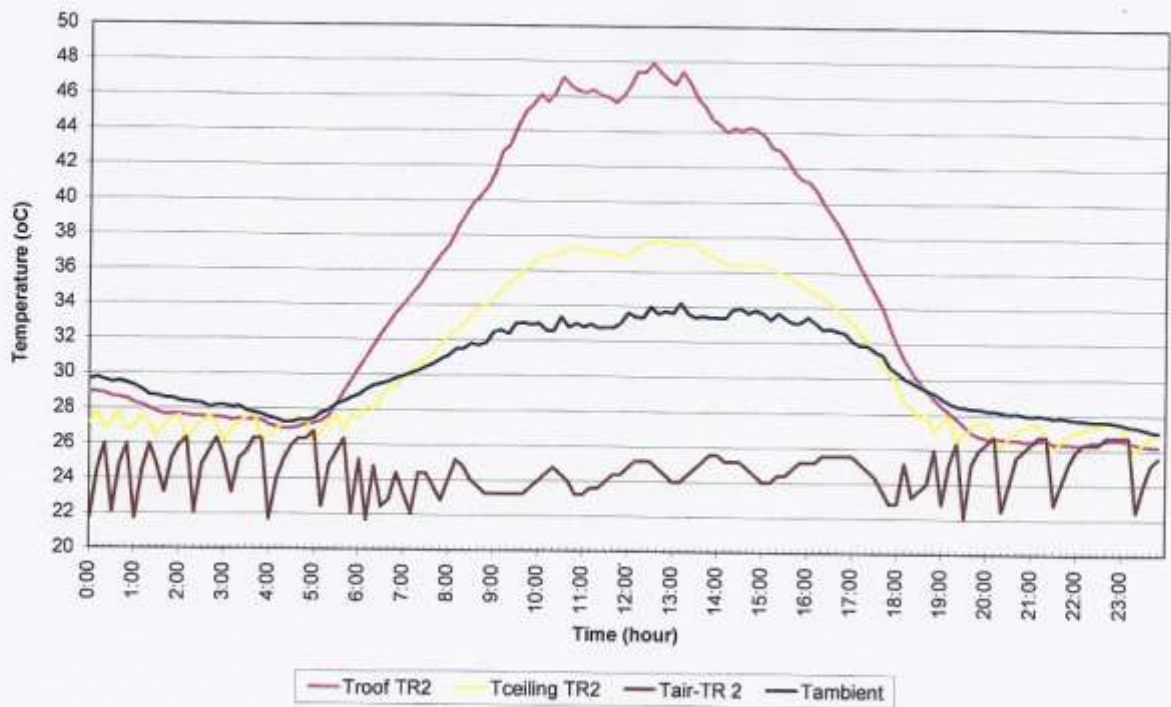
Figure 29. Roof, ceiling temperature distribution - Test Room 2 (July 22nd).

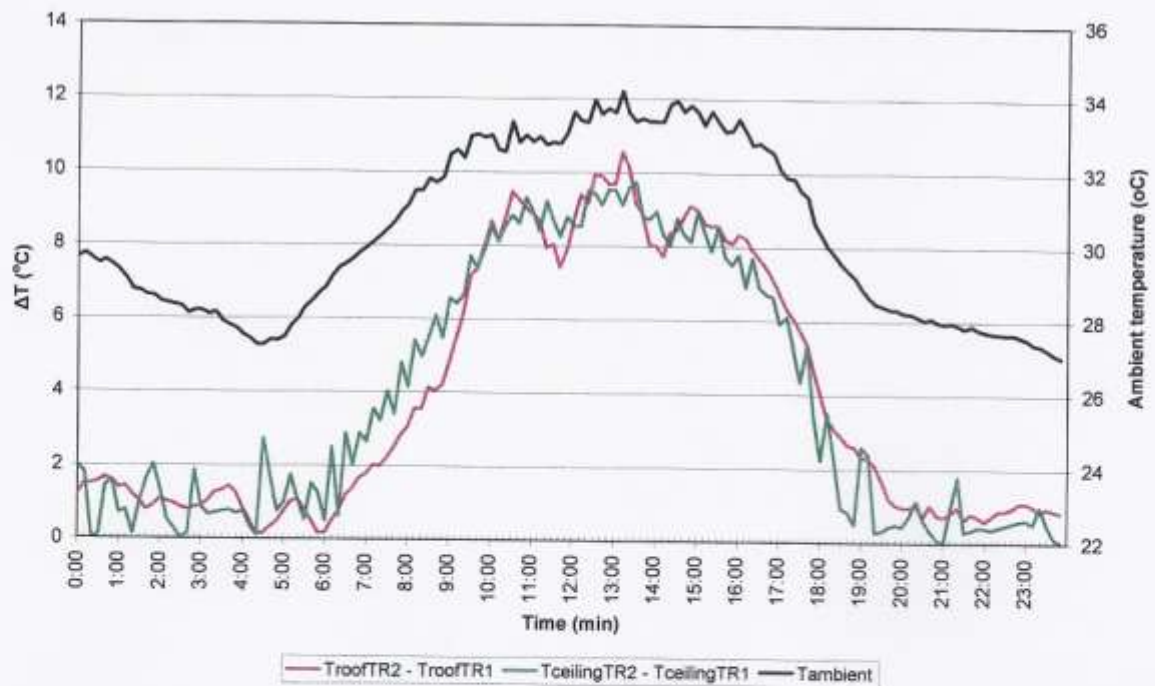
Figure 30. Roof, ceiling temperature difference (July 22nd).

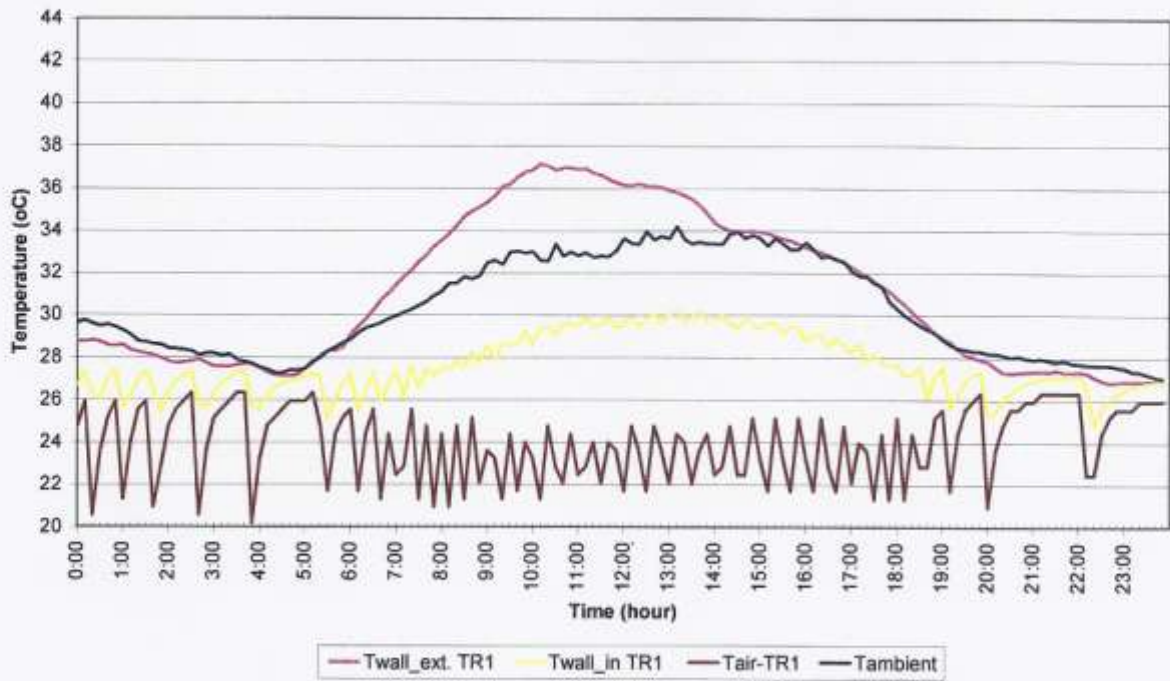
In Figure 31 the wall internal and external temperature distribution for Test Room 1 is presented. The same data for Test Room 2 are shown in Figure 32. It can be seen that during sunshine hours the exterior wall temperature of Test Room 2 is always higher than that of Test Room 1 and reaches up to 5 °C difference (Figure 33). The interior wall temperature of Test Room 2 is, again, always higher than that of Test Room 1 and reaches up to 4.5 °C difference (Figure 33). The daily average exterior wall temperature difference was found to be 2.4 °C.

Figure 31. Wall surface temperature distribution - Test Room 1 (July 22nd).

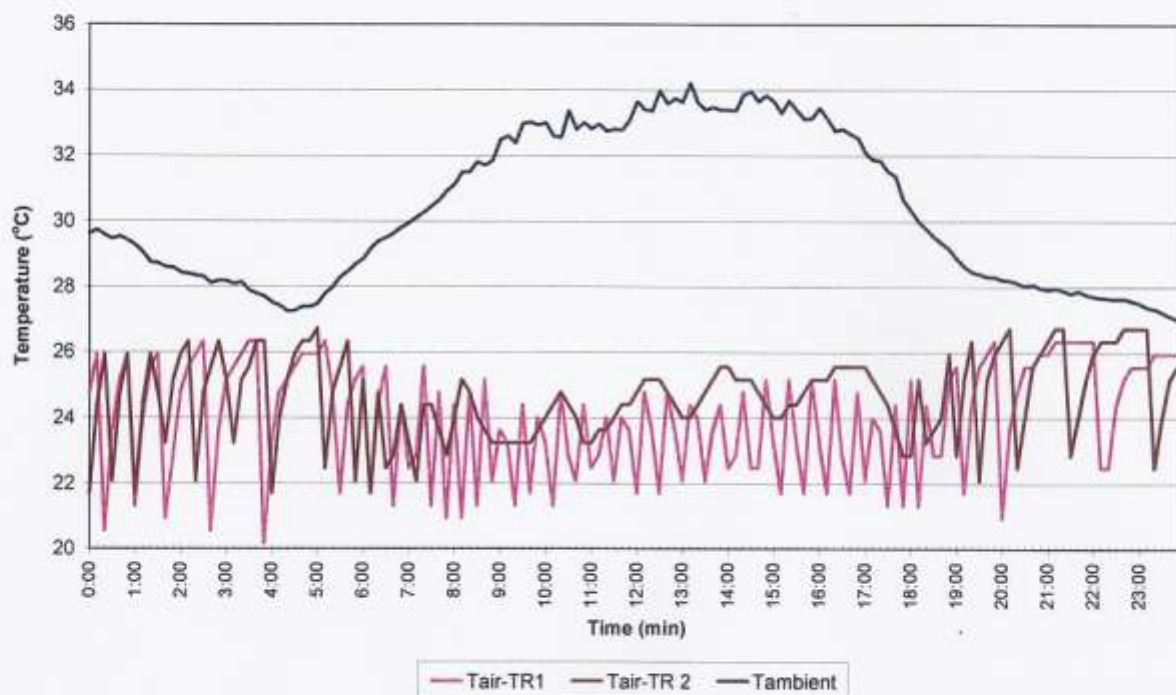
Figure 34 shows the indoor air temperature distribution of the two Test Rooms. Both air temperatures are very close to the set point and remain almost constant on a 24-hour basis. A slight difference between the temperatures is observed, with the air temperature of Test Room 2 being higher than that of Test Room 1, implying the ability of Test Room 1 to keep the temperature in low levels which corresponds to less energy needs. The average temperature of Test Room 1 is 24 °C while that of Test Room 2 was found to be 24.6 °C.

Figure 34. Indoor air temperature (July 22nd).

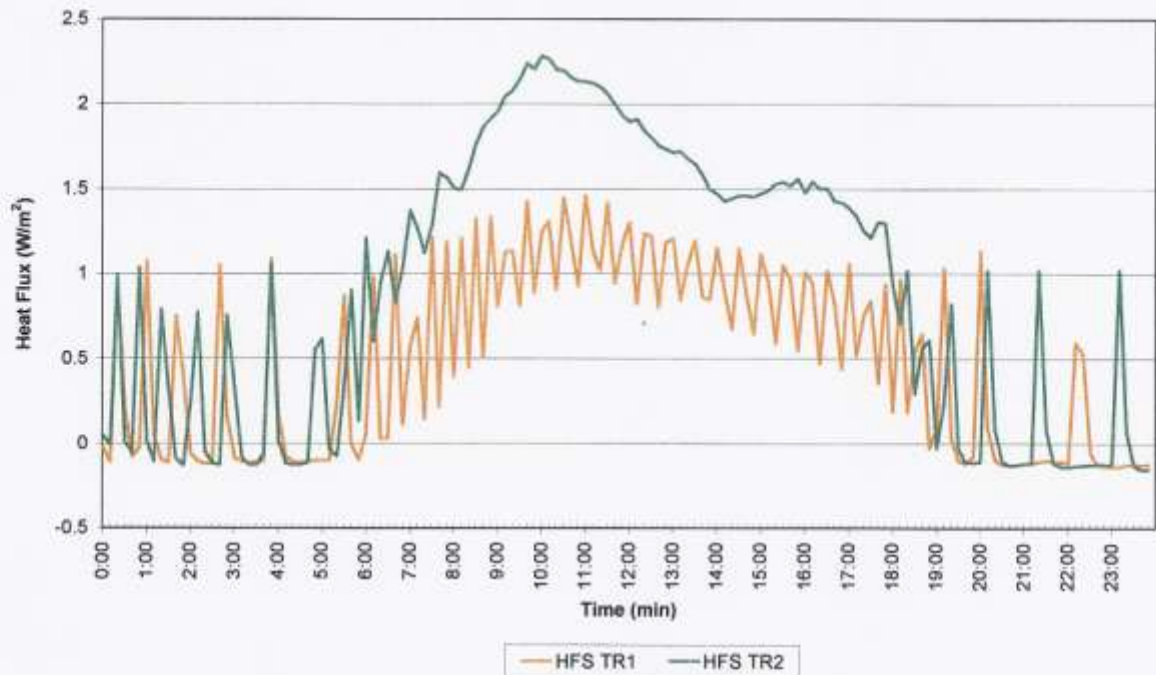
Figure 35 depicts the heat losses from the walls of the Test Rooms. It can be seen that during sun hours, the heat losses of Test Room 2 are higher than those of Test Room 1, however, during nighttime they balance. The average heat losses difference is 0.41 W/m^2 which corresponds to 56% less energy losses.

Figure 35. Wall heat losses (July 22nd).

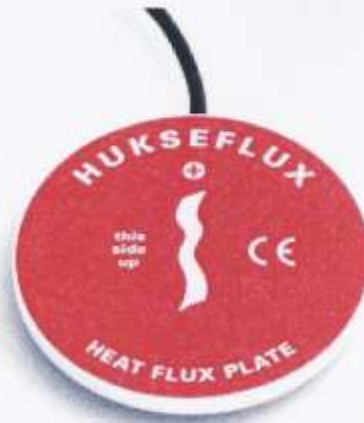
From the measurements collected a calculation of the thermal Resistance, R of the walls of the Test Rooms took place. The sensors used are: the 2 wall surface temperatures of Test Room 1 (external and internal), and the heat flux sensor HFS TR1. The heat flux sensor was placed in full contact with the internal wall area and measured the conductive and convective heat transfer (refer to Figures 36 and 6). The same sensors readings were used for Test Room 2.

Figure 36. Heat Flux sensor.

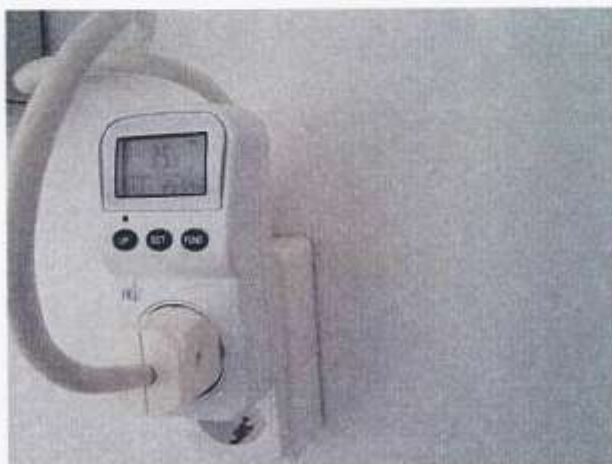
The energy needs to keep the air temperature of the Test Rooms in a controlled environment were also recorded by the use energy meters. So, during the test procedure, an energy meter has been connected to the air conditioner in order to record the electrical energy consumed by the unit to keep the indoor temperature to 26 °C. The energy meter measured the electricity needs continually and recorded the readings at the end of the measuring sequence. The two energy meters installed in the Test Rooms can be seen in Figures 39 and 40. The data from the energy meters can be found in Table 2.

Figure 39. Energy meter in Test Room 1.

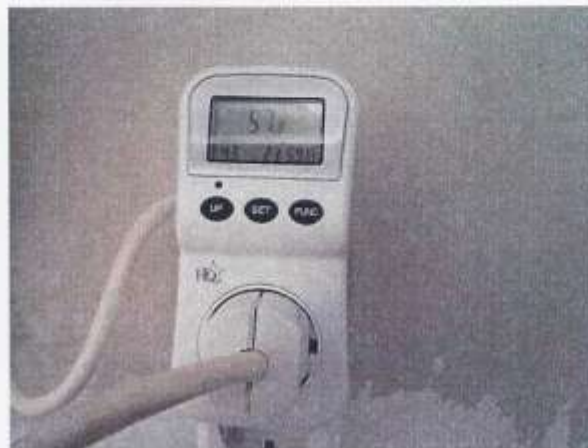
Figure 40. Energy meter in Test Room 2.

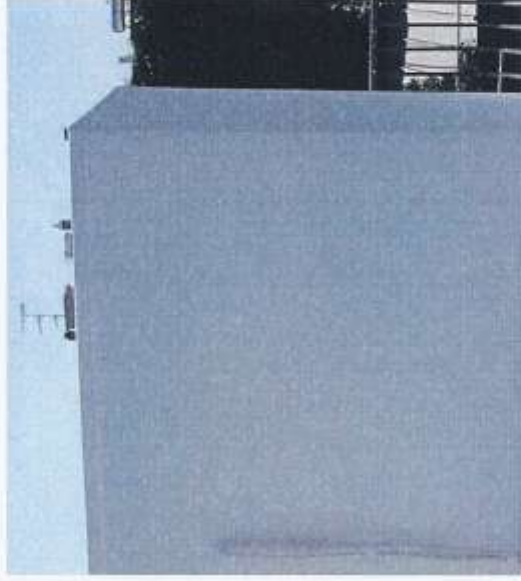
Measurement Point	Temperature (°C)
SP01	34.1°C
SP02	33.6°C
SP03	34.1°C
SP04	34.2°C
SP05	33.2°C
SP06	34.7°C
SP07	35.1°C
SP08	33.8°C

Figure A4: North façade, upper part - Test Room 1

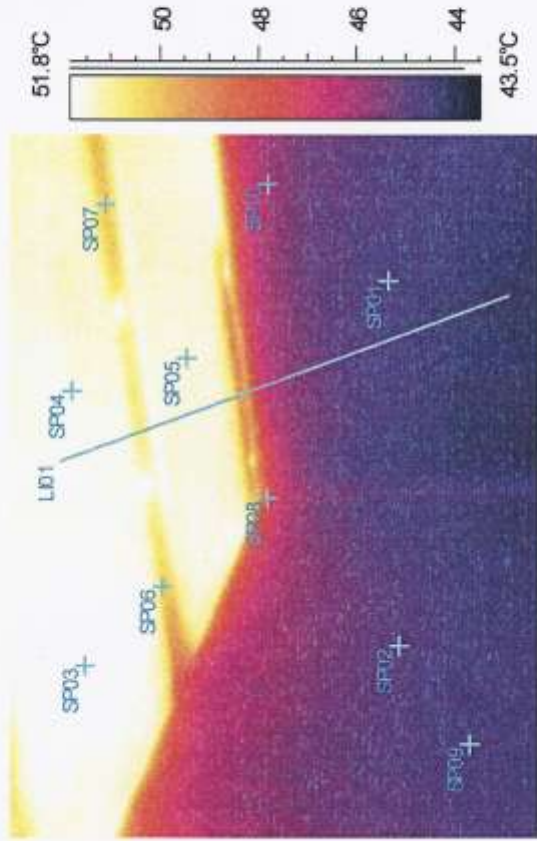
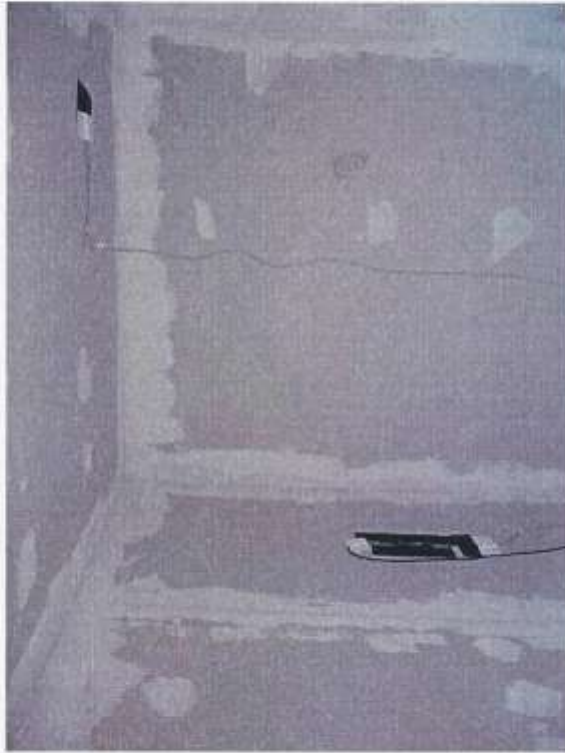
Measurement Point	Temperature (°C)
SP01	44.8°C
SP02	44.9°C
SP03	52.1°C
SP04	51.6°C
SP05	51.5°C
SP06	50.1°C
SP07	50.2°C
SP08	48.5°C
SP09	44.6°C
SP10	46.2°C

Thermograph 8: Wall-ceiling joint, Test Room 2

Figure A8: Wall-ceiling joint, Test Room 2

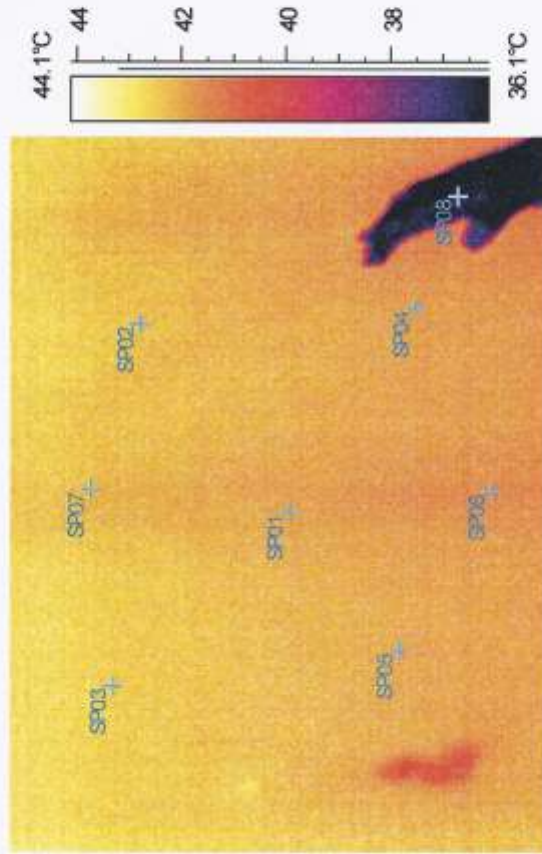
Figure A9: Wall surface, internal – Test Room 2

Thermograph 9: Wall surface, internal – Test Room 2

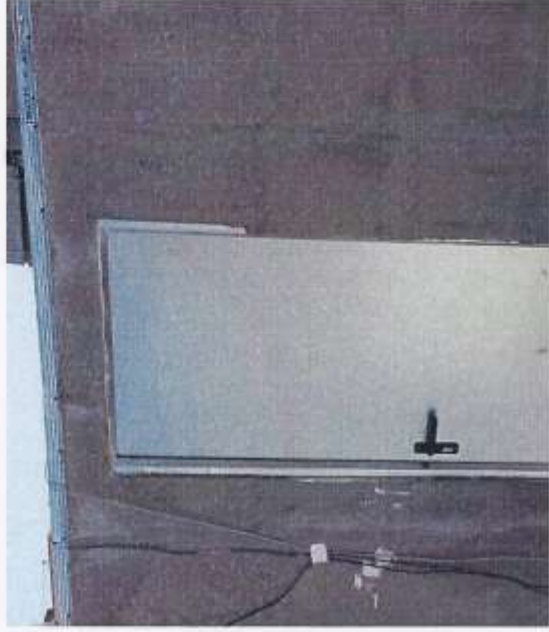
Measurement Point	Temperature (°C)
SP01	38.8°C
SP02	38.1°C
SP03	37.4°C
SP04	38.0°C
SP05	32.5°C
SP06	41.5°C
SP07	34.8°C
SP08	38.6°C

Thermograph 10: South façade, Test Room 2

Figure A10: South façade, Test Room 2
